New Mexico Plant Materials Center Los Lunas, New Mexico

2001 Progress Report Demonstration Planting

**El Pueblo Acequia, Pecos River
San Miguel County, New Mexico**

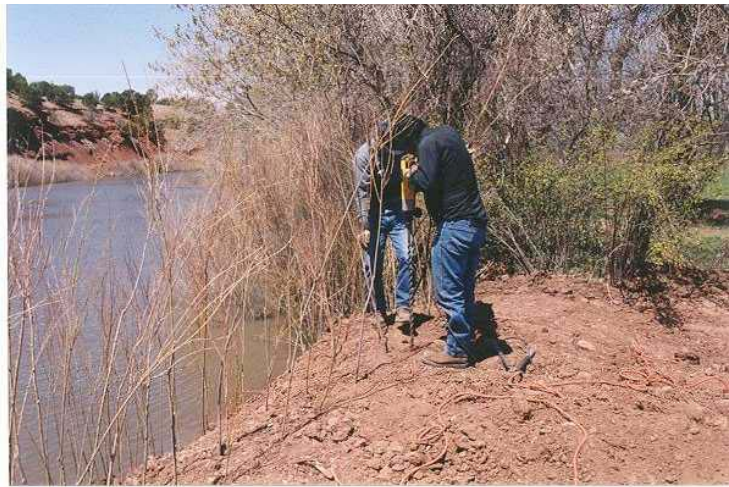
Figure 3: Planting Coyote willow using a hammer drill.

The Hammer drills worked moderately well in the rocky soil. They were able to generate 3-foot holes most of the time. However, the drill bits did get jammed between the rocks in some holes preventing them from rotating. Consequently, the drill would spin instead of the bit, forcing the operator to release the drill.

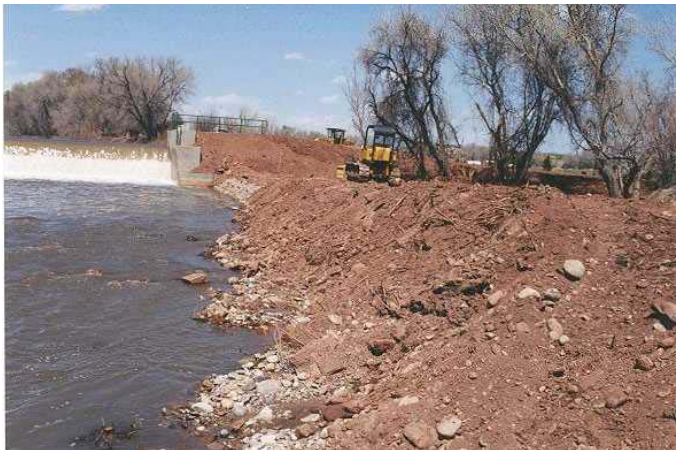
Figure 4: Newly contoured riverbank before planting

With one drill, two people can plant 500 willow poles per day to a 3-foot depth. The new riverbank was built with a small bulldozer on somewhat steep slopes nearly at the angle of

repose (see Figure 4).

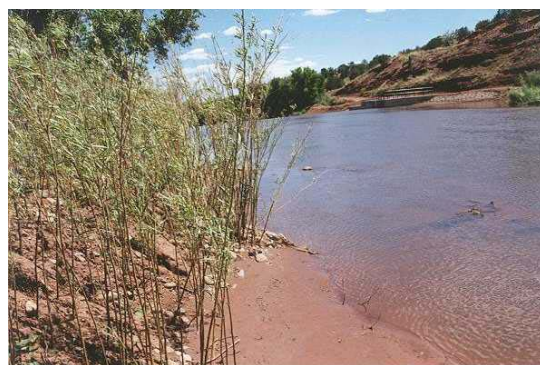
Figure 5: Willows planted to edge of river

Because of the steep incline of the bank, willows were planted at a relatively dense rate on approximately 1-foot centers from the edge of the river to the crest of the bank. To help stabilize the bank, the willows were planted for approximately 200 linear feet (see Figures 5 and 6).
